# **VII. ROAD, UTILITY AND BUILDING INVENTORY**

## FACILITY INVENTORY AND INSPECTION PROGRAM

### Raven Rock State Park Building Inventory

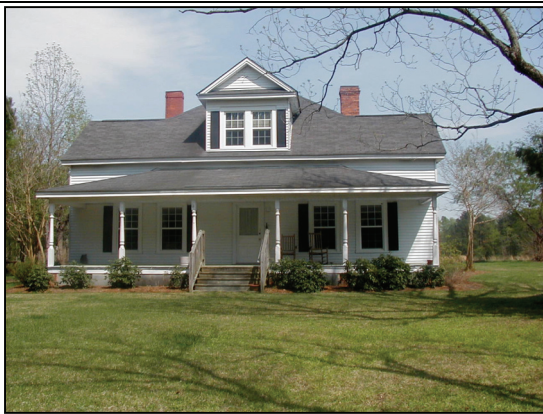
**Figure VII-1. Ranger Residence # 20-021.** Built in 1920. 1675 square feet. Heated wood-frame structure used as Superintendent's residence. A capital improvement project has been developed to bring the old structure up to current standards, including utility improvements and the addition of a bathroom and detached carport.

5. Superintendent Residence (Building # 20-021) - This system has a 1200-gallon septic tank with two or three drain lines of unknown length. The drain lines seem to be functioning satisfactorily. There is a riser installed at this location.

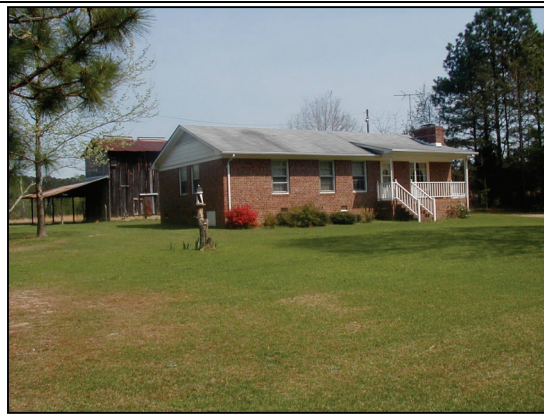
**Figure VII-2. Ranger Residence # 20-018.** Built in 1980. 1213 square feet. Heated wood-frame structure with brick veneer. Guest bath partially remodeled and used as a laundry.  
**Tobacco Barn #20-019.** Built in 1950. Unheated wood-frame structure used for storage.

4. Ranger Residence (Building # 20-018) – This system has a 1000-gallon septic tank with three 100-foot drain lines located in the front yard. The drain lines seem to be functioning satisfactorily. A riser has been installed at this location.

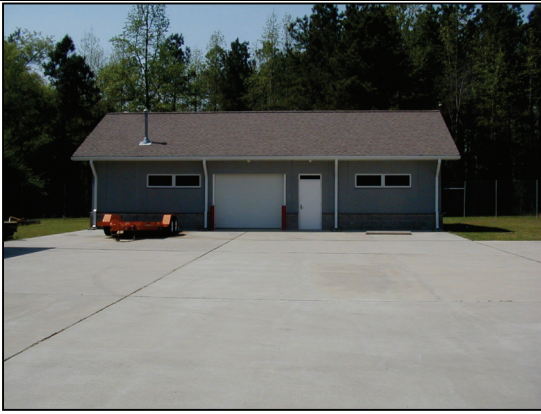
**Figure VII-3. Warehouse #20-028.** Built in 1998. 1422 square feet. Heated CMU building serves as the park warehouse.

3. Warehouse – This system has a 1000-gallon septic tank with two 60-foot drain lines. The drain lines seem to be functioning satisfactorily. There is no riser at this location.

According to staff, it has been two years since any of the septic systems have been pumped. Each system should be scheduled for pumping within the next year. Risers should be added to the septic systems located at the Maintenance Shop and Warehouse.

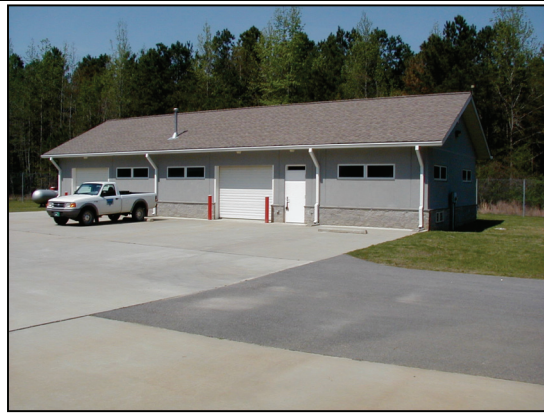
**Figure VII-4. Maintenance Building #20-027.** Built in 1998. 1985 square feet. Heated CMU building used as maintenance office and shop.

2. Maintenance Shop – This system has a 1000-gallon septic tank with two 60-foot drain lines. The drain lines seem to be functioning satisfactorily. There is no riser at this location.

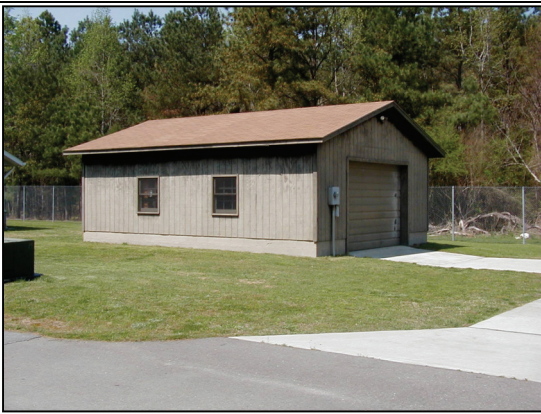
**Figure VII-5. Small Engine Shop #20-026.** Built in 1994. 616 square feet. Heated wood-frame building used for lawn mower storage and repair.

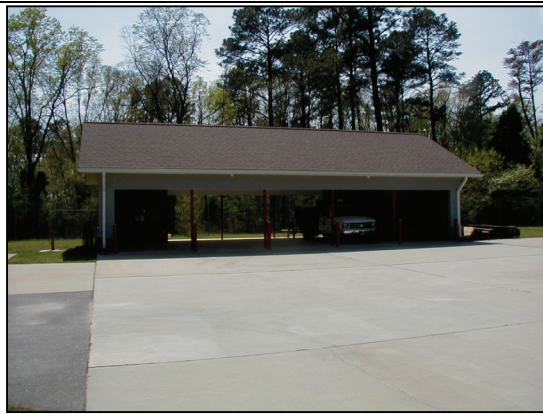
**Figure VII-6. Vehicle Storage Building #20-029.** Built in 1998. 1512 square feet. Unheated, partially open CMU and metal post and beam structure used for vehicle storage.

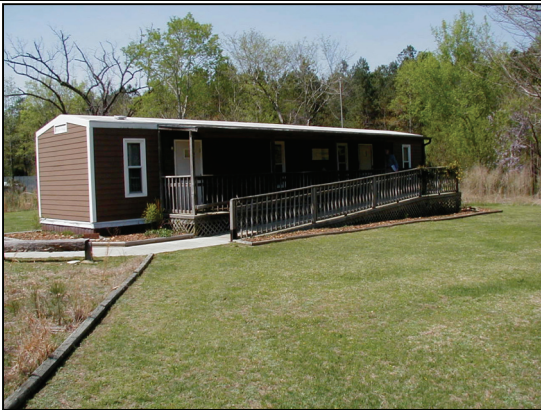
**Figure VII-13. Park Office #20-025.** Built in 1992. 672 square feet. Heated, manufactured wood and metal frame mobile home used as the park office.

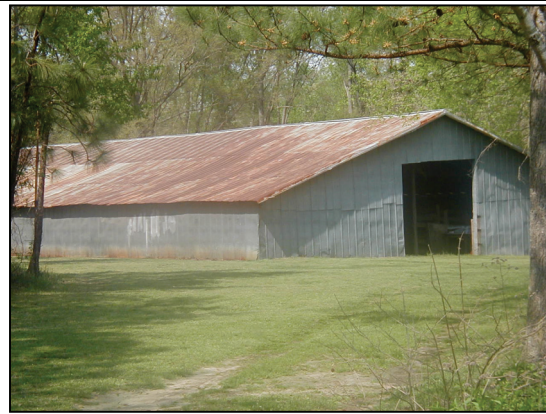
**Figure VII-8. V-Crimp Tin Barn #20-023.** Built in 1960. 5000 square feet. Unheated wood post and beam structure used for storage.

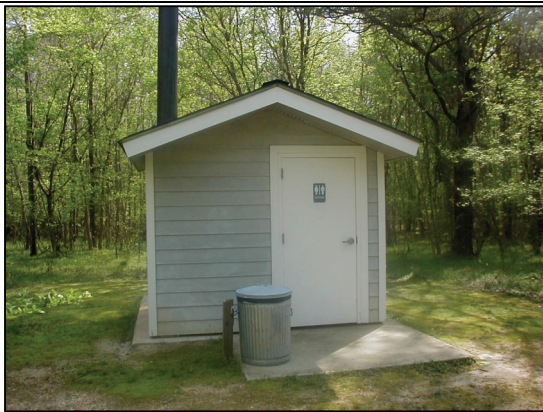
**Figure VII-9. Canoe Camp Toilet #20-032.** Built in 1997. 82 square feet. Unheated, metal-stud frame structure has cement siding. The toilet is a vault, pump and haul type facility.

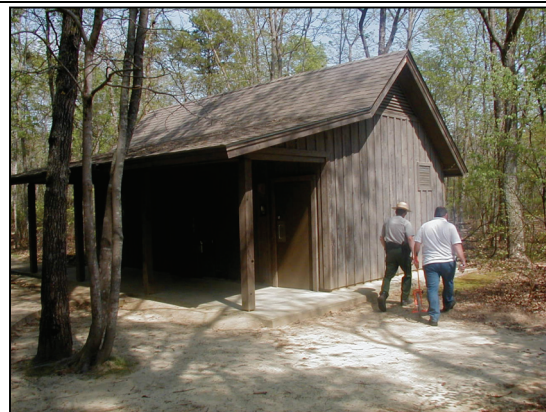
**Figure VII-10. Picnic Area Toilet Building #20-002.** Built in 1986. 436 square feet. Partially heated, wood-frame structure.

1. Toilet Building (Building # 20-002) – This system has a 1500-gallon septic tank with four 110-foot drain lines. The drain lines seem to be functioning satisfactorily. The drain field is in a wooded area with trees growing over it. A riser has been installed at this location.

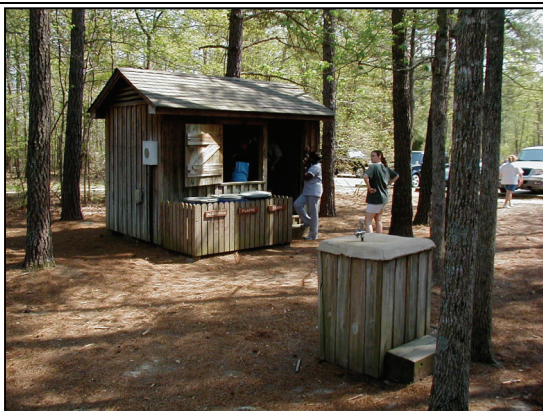
**Figure VII-11. Vending Machine Building #20-015.** Built in 1978. 88 square feet. Unheated wood-frame structure used to store public-use vending machines.

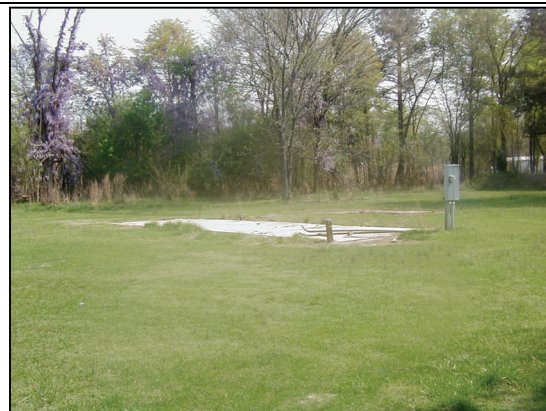
**Figure VII-12. Mobile Home Site.**

6. Alternate Ranger Residence Location – Mobile home occupied by a ranger is currently at this site. This system has a 1000-gallon septic tank with three 100-foot drain lines located in the front yard. A riser has been installed at this location.
